# HYPERVELOCITY IMPACT EVALUATION OF METAL FOAM CORE SANDWICH STRUCTURES

Hypervelocity Impact Technology Facility (HITF)
Astromaterials Research and Exploration Science (ARES) Directorate
KX – Human Exploration Science Office

### August 2007

Prepared for the JSC Center Director Discretionary Fund (CDDF) Research Project

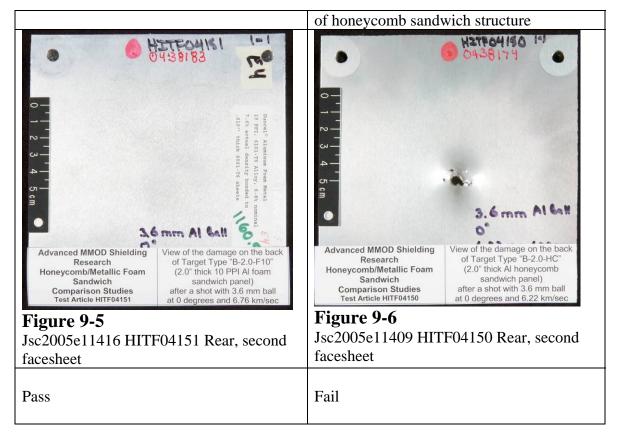
**Figure 9-4**Jsc2007e21476 HITF04150 Cross section

The following comparison of pictures show the damage done to the aluminum foam compared to the aluminum honeycomb. The foam article in these images performs better, has a lower areal density, and was impacted by the same size projectile as compared to the honeycomb.

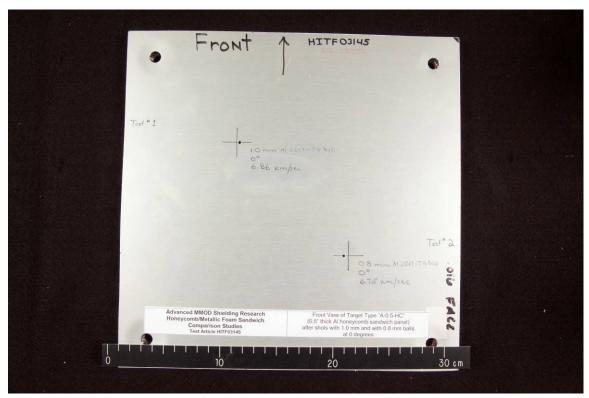
**Figure A-1**Jsc2005e11293 HITF03145 Front, first facesheet

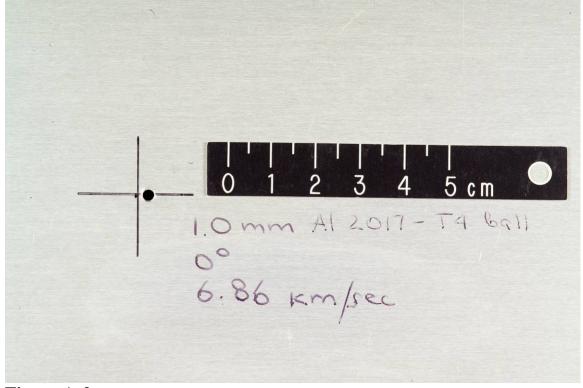
Figure A-2
Jsc2005e11291 HITF03145-1 Front, first facesheet

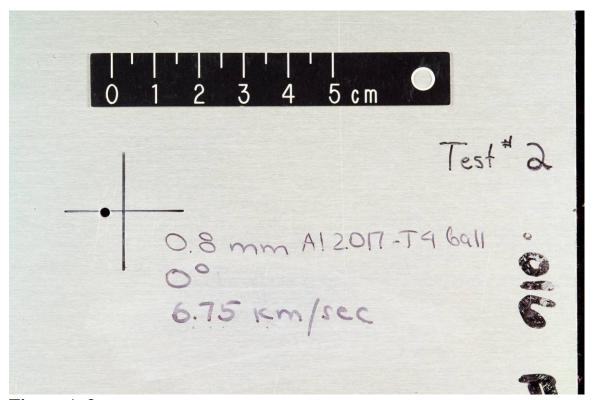
**Figure A-3**Jsc2005e11292 HITF03145-2 Front, first facesheet

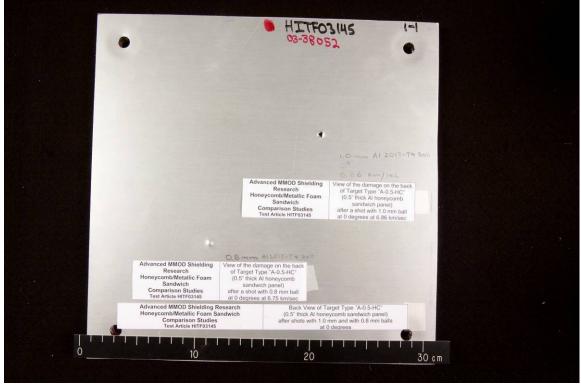
**Figure A-4**Jsc2005e11288 HITF03145 Rear, second facesheet

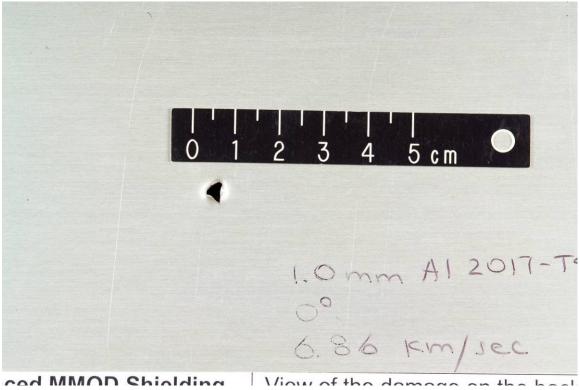
Figure A-5

Jsc2005e11289 HITF03145-1 Rear, second facesheet

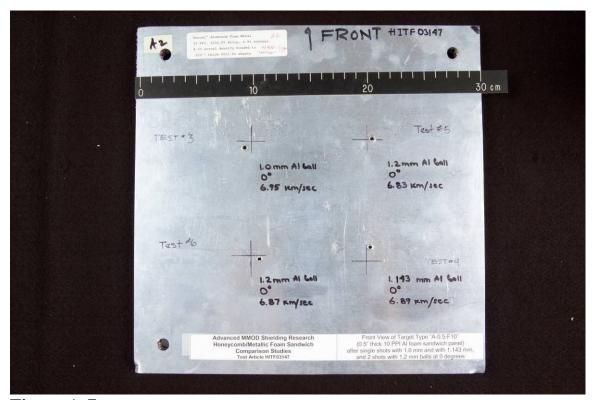
**Figure A-7**Jsc2005e11299 HITF03147 Front, first facesheet

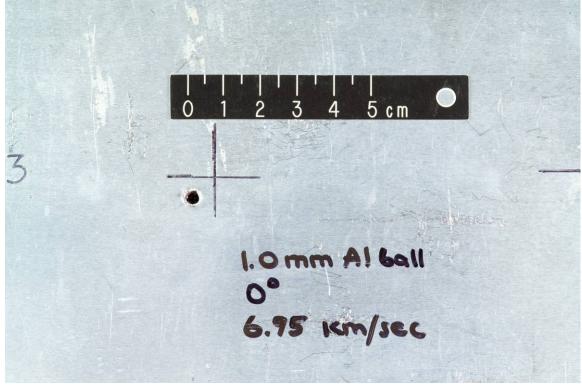
Figure A-8
Jsc2005e11300 HITF03147-1 Front, first facesheet

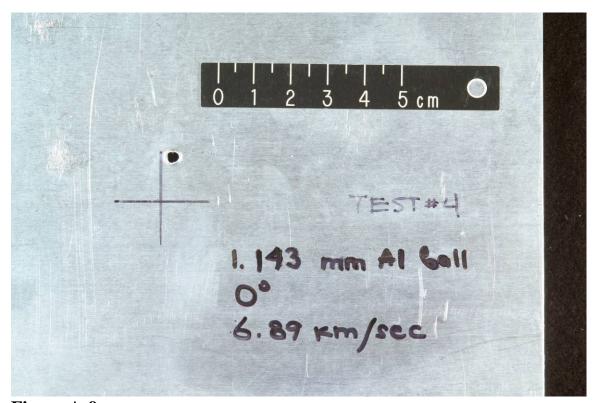
**Figure A-9**Jsc2005e11303 HITF03147-2 Front, first facesheet

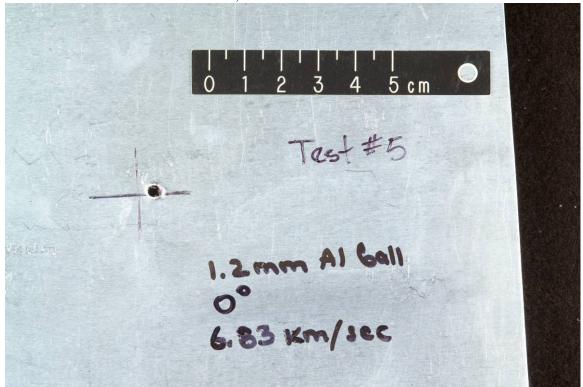
**Figure A-10**Jsc2005e11301 HITF03147-3 Front, first facesheet

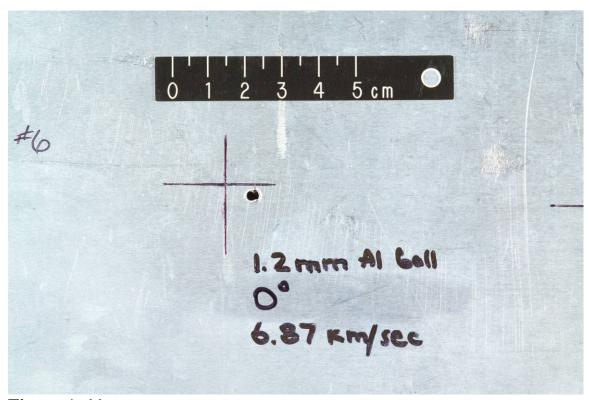
**Figure A-11**Jsc2005e11302 HITF03147-4 Front, first facesheet

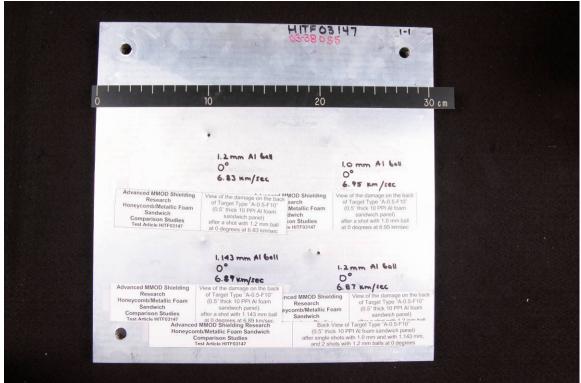
**Figure A-12**Jsc2005e11294 HITF03147 Rear, second facesheet

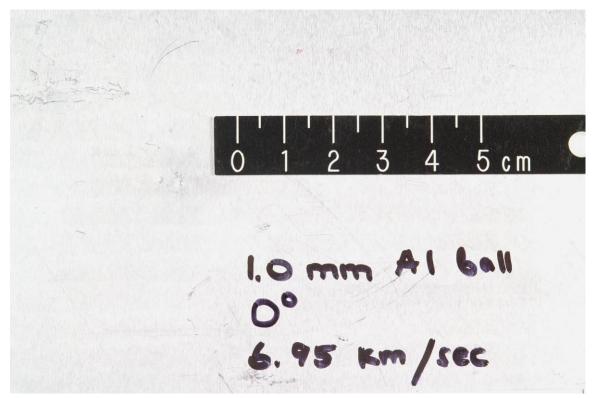
**Figure A-13** Jsc2005e11296 HITF03147-1 Rear, second facesheet

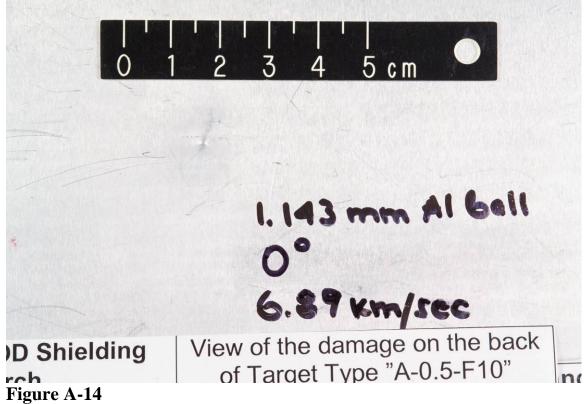
Jsc2005e11297 HITF03147-2 Rear, second facesheet

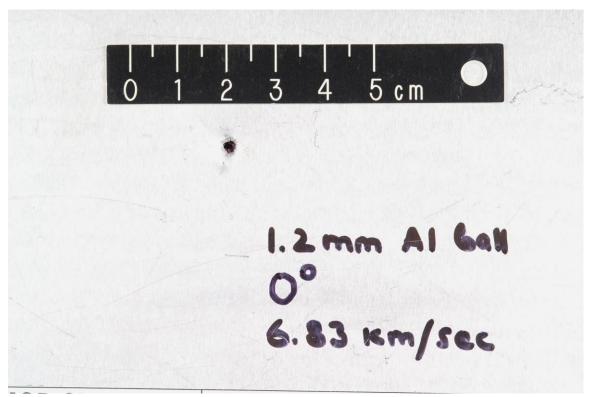
**Figure A-15**Jsc2005e11295 HITF03147-3 Rear, second facesheet

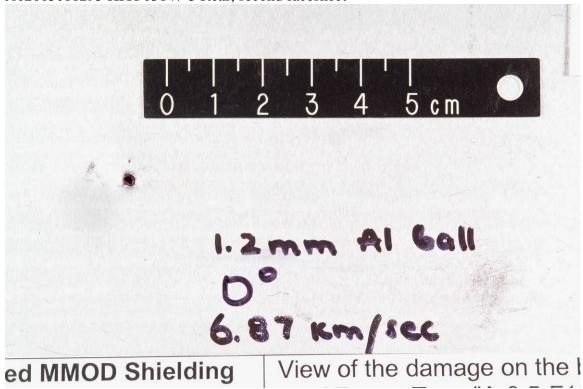
**Figure A-16**Jsc2005e11298 HITF03147-4 Rear, second facesheet

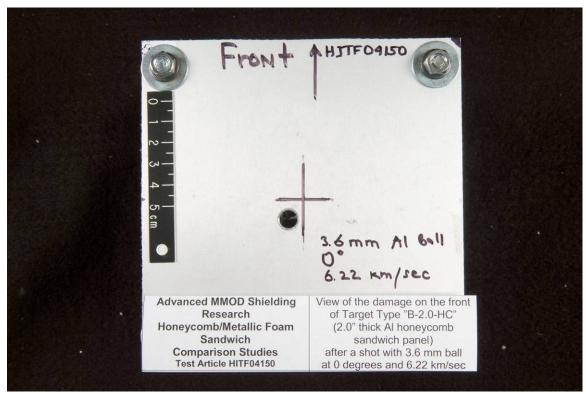
**Figure A-17**Jsc2005e11402 HITF04150 Front, first facesheet

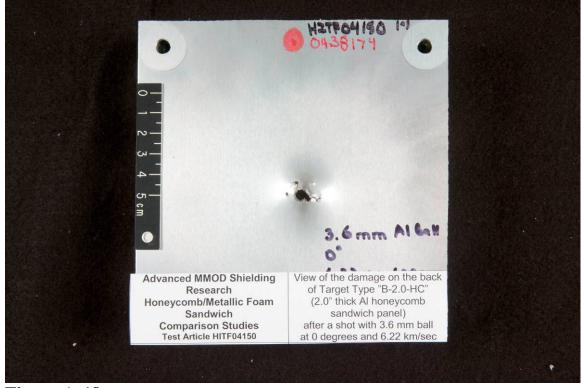
**Figure A-18**Jsc2005e11409 HITF04150 Rear, second facesheet

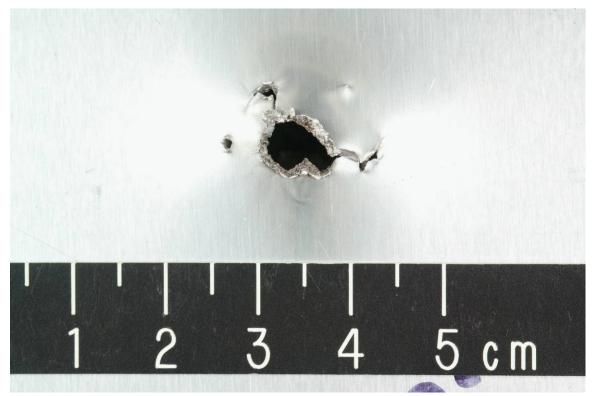
Figure A-19
Jsc2005e11410 HITF04150 Rear, second facesheet

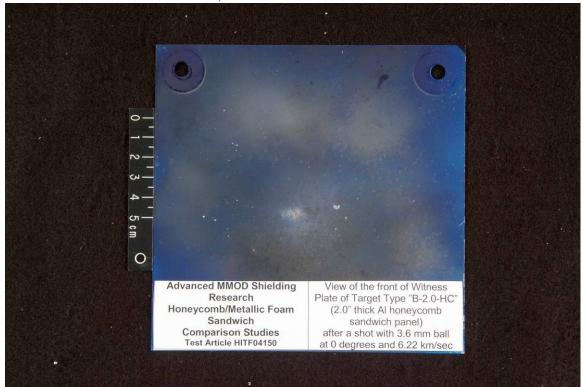
Figure A-20
Jsc2005e11408 HITF04150 Front witness plate

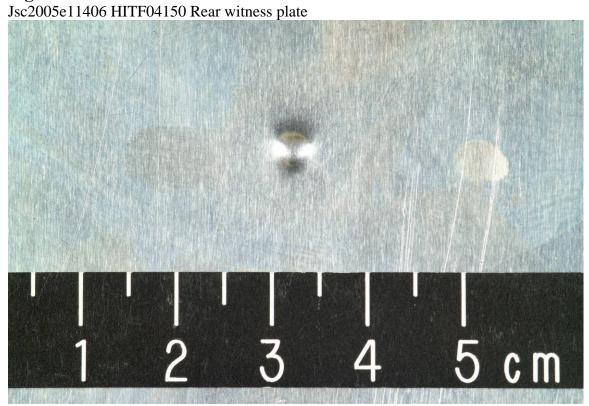
Figure A-22
Jsc2005e11407 HITF04150 Rear witness plate

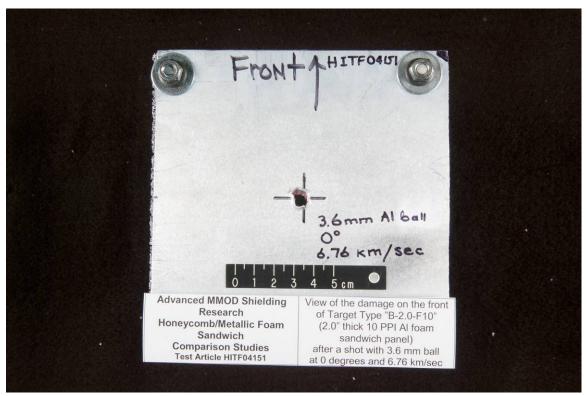
Figure A-23
Jsc2005e11412 HITF04151 Front, first facesheet

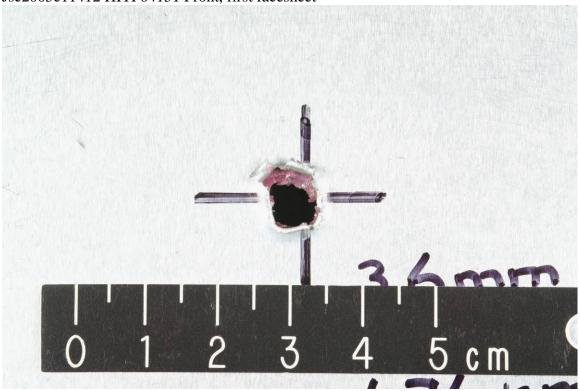
Figure A-24
Jsc2005e11411 HITF04151 Front, first facesheet

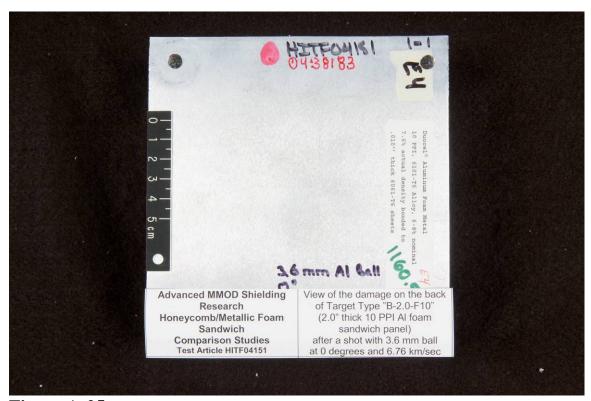
**Figure A-25**Jsc2005e11416 HITF04151 Rear, second facesheet

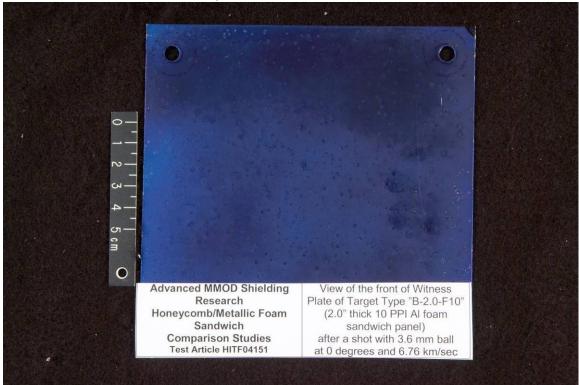
**Figure A-26**Jsc2005e11415 HITF04151 Front witness plate

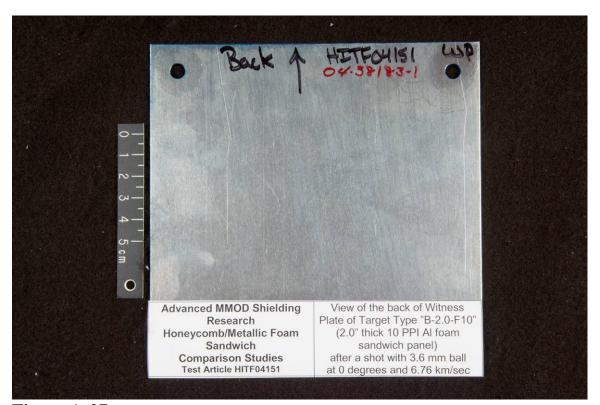
**Figure A-27**Jsc2005e11414 HITF04151 Rear witness plate

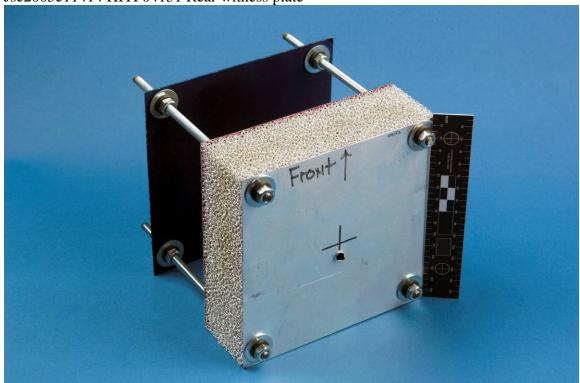
**Figure A-28** Jsc2007e21462 HITF04152 Oblique

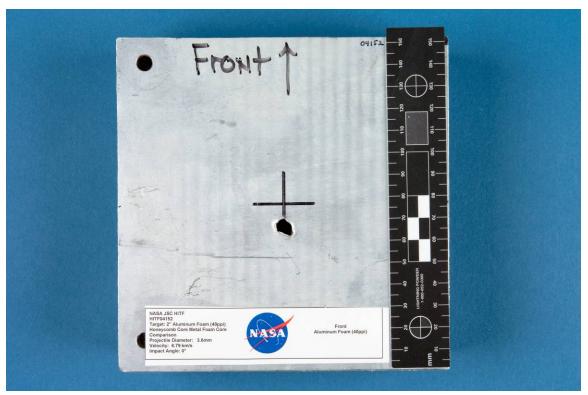
Figure A-29
Jsc2007e21467 HITF04152 Front, first facesheet

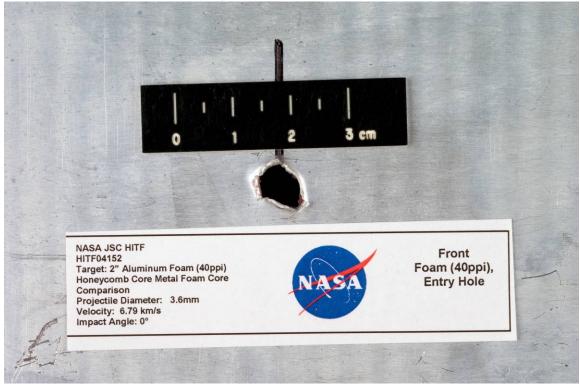
**Figure A-30**Jsc2007e21477 HITF04152 Front, first facesheet

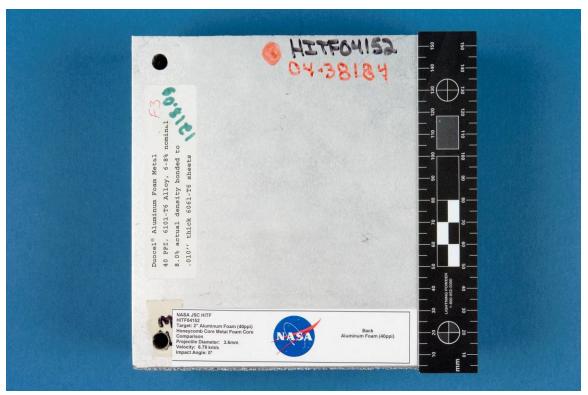
Figure A-31
Jsc2007e21468 HITF04152 Rear, second facesheet

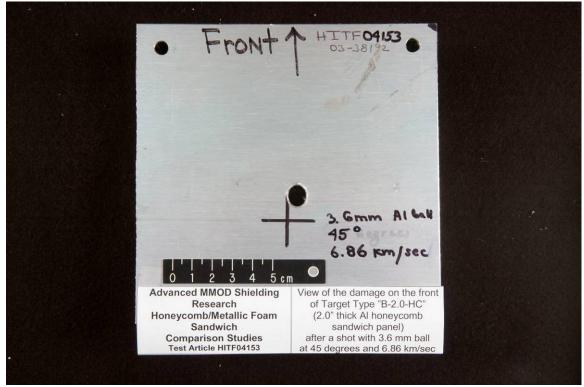
**Figure A-32** Jsc2005e11286 HITF04153 Front, first facesheet

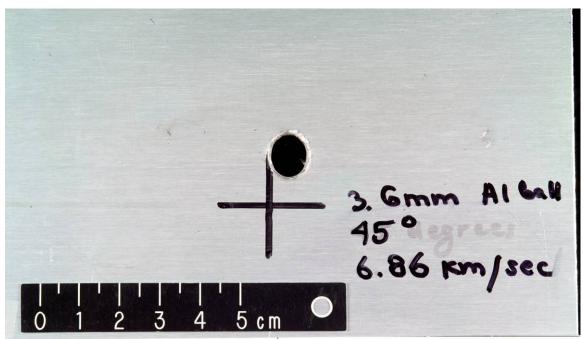
**Figure A-33** Jsc2005e11287 HITF04153 Front, first facesheet

View of the damage on the front of Target Type "B-2.0-HC"

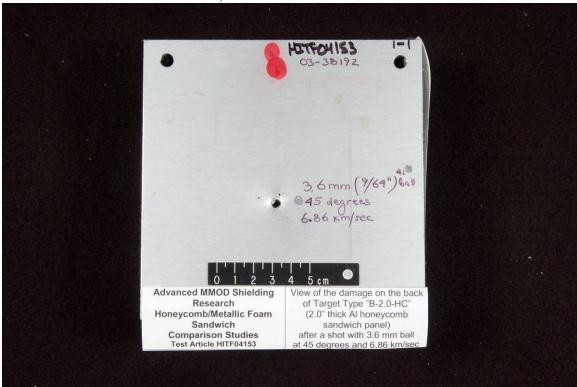
**Figure A-34**Jsc2005e11283 HITF04153 Rear, second facesheet

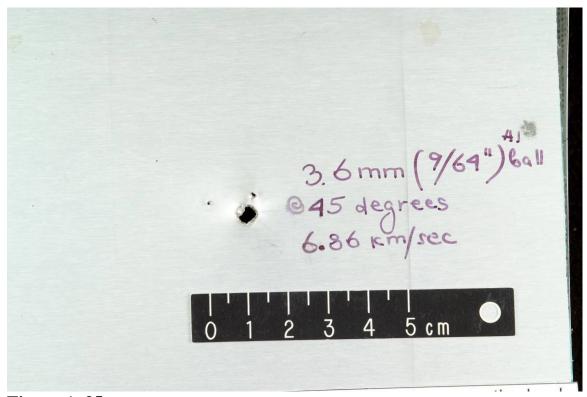
**Figure A-35**Jsc2005e11284 HITF04153 Rear, second facesheet

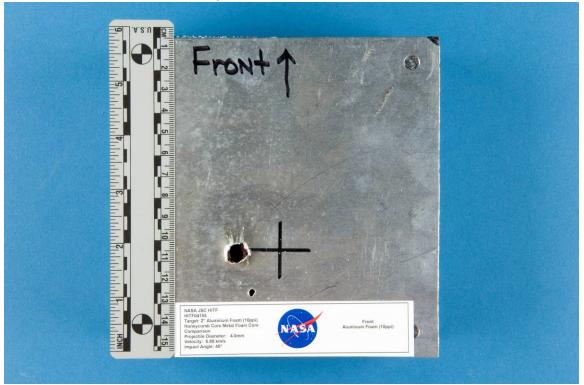
**Figure A-36**Jsc2007e14139 HITF04155 Front, first facesheet

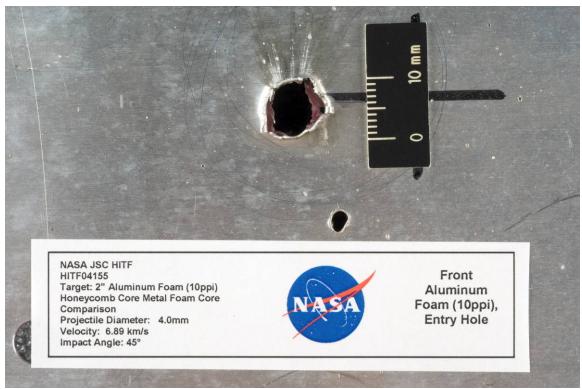
Figure A-37
Jsc2007e14196 HITF04155 Front, first facesheet

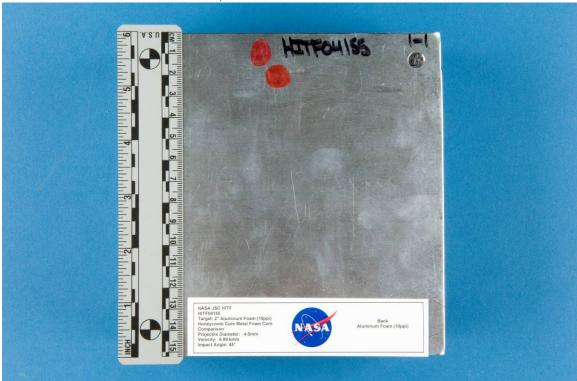
**Figure A-38**Jsc2007e14140 HITF04155 Rear, second facesheet

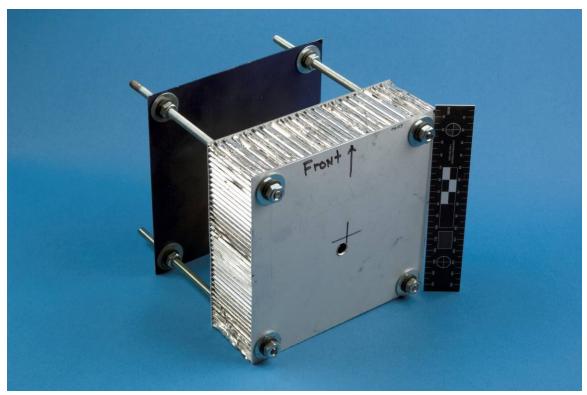
**Figure A-39**Jsc2007e21461 HITF04159 Oblique

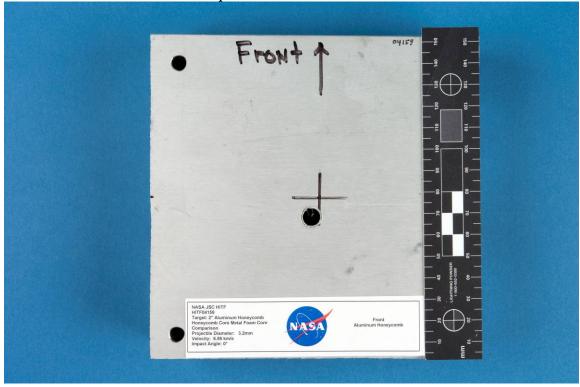
Figure A-40
Jsc2007e21463 HITF04159 Front, facesheet

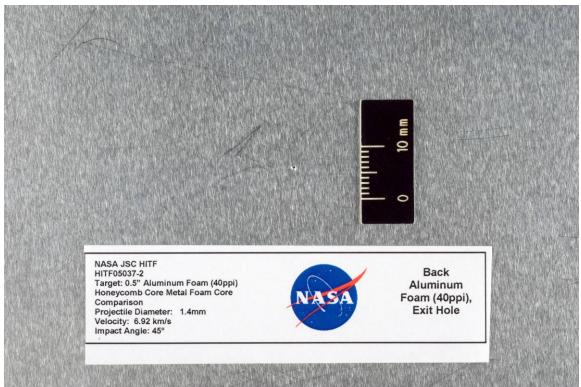
**Figure A-80**Jsc2007e14158 HITF05037 Rear, second facesheet

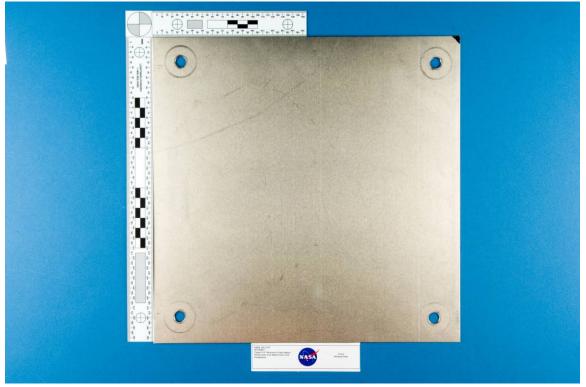
**Figure A-81**Jsc2007e14185 HITF05037-2 Rear, second facesheet

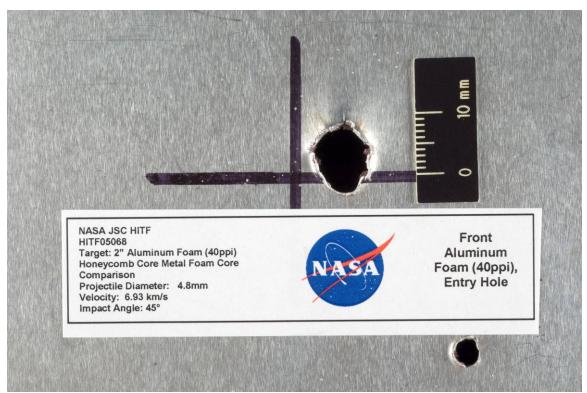
**Figure A-84**Jsc2007e14145 HITF05068 Front, first facesheet

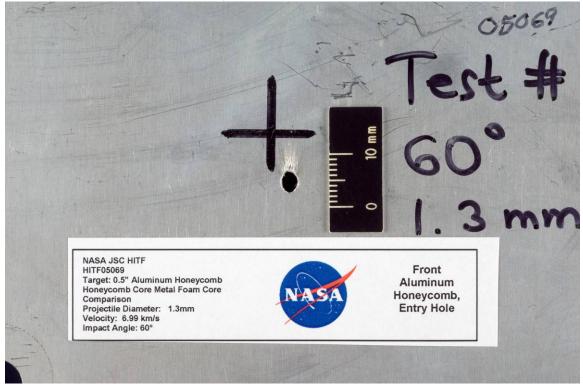
Figure A-87
Jsc2007e14161 HITF05069 Front, first facesheet

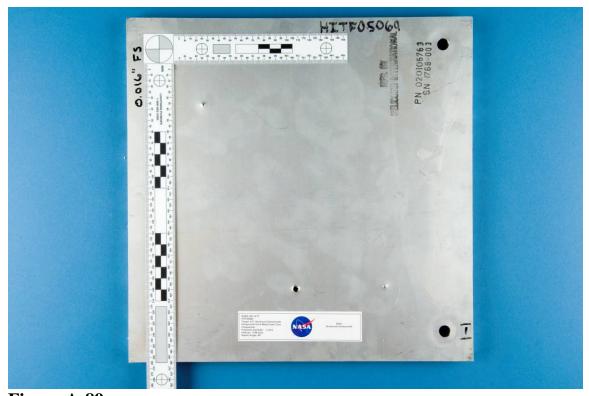
Figure A-88
Jsc2007e14186 HITF05069 Front, first facesheet

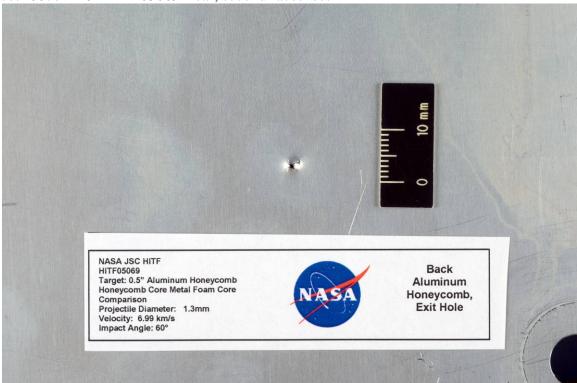
**Figure A-89**Jsc2007e14162 HITF05069 Rear, second facesheet

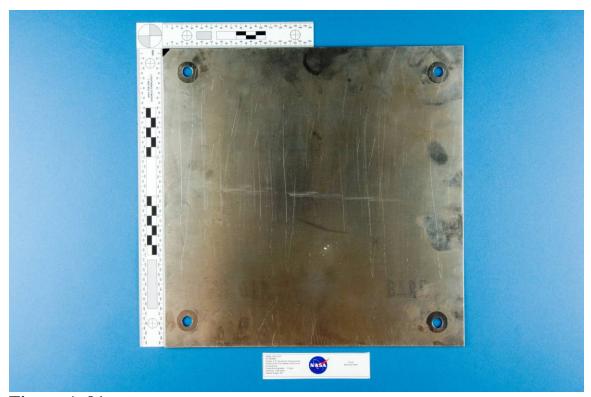
**Figure A-90**Jsc2007e14187 HITF05069 Rear, second facesheet

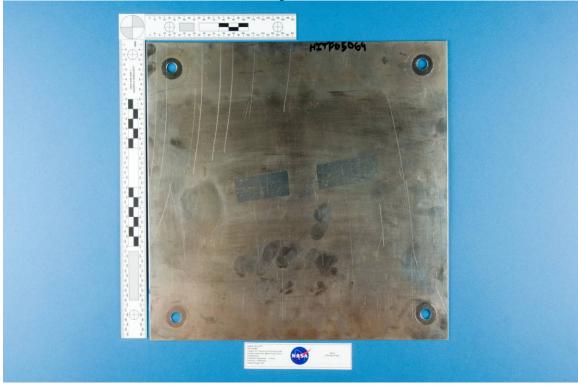
**Figure A-91**Jsc2007e14159 HITF05069 Front, witness plate

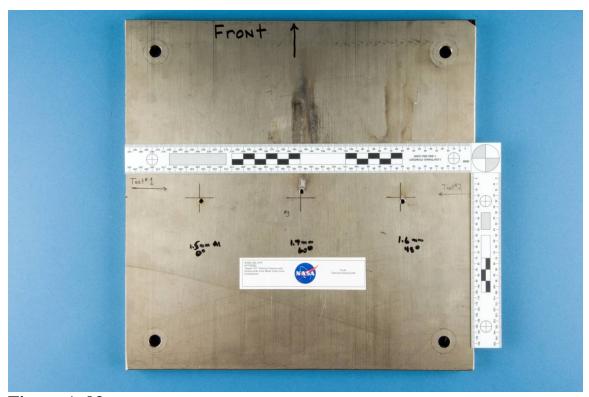
**Figure A-92**Jsc2007e14160 HITF05069 Rear, witness plate

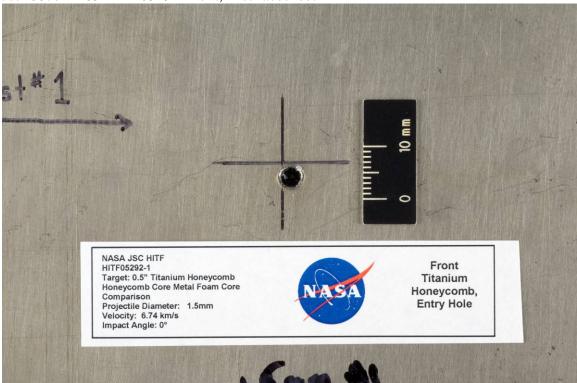
Figure A-93
Jsc2007e14165 HITF05292 Front, first facesheet

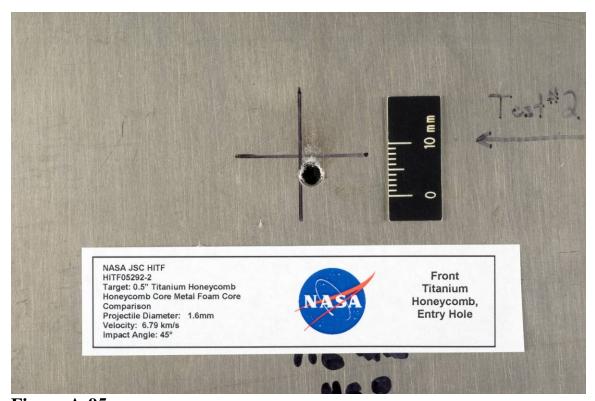
Figure A-94
Jsc2007e14188 HITF05292-1 Front, first facesheet

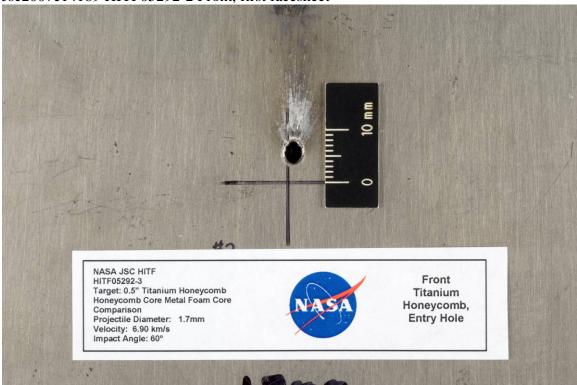
Figure A-95
Jsc2007e14189 HITF05292-2 Front, first facesheet

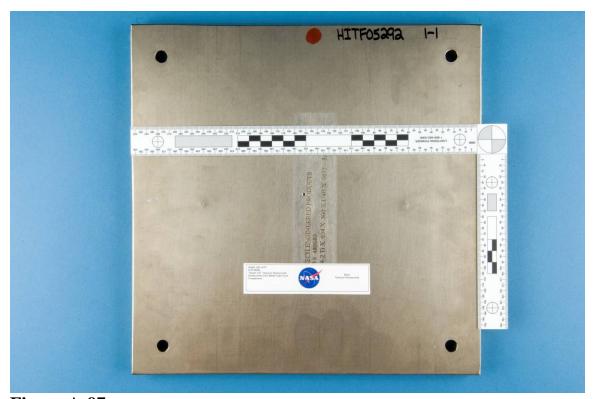
Figure A-96
Jsc2007e14190 HITF05292-3 Front, first facesheet

HITF05292-3	6.90	60	Fail	4.1	3.3
HITF04151	6.76	0	Pass	7.9	6.0
HITF04161	6.89	0	Fail	8.7	7.4
HITF04155	6.89	45	Pass	9.5	8.7
HITF04162	6.92	45	Pass	12.0	8.9
HITF04152	6.79	0	Pass	8.5	5.4
HITF04163	6.79	0	Fail	11.0	9.1
HITF04164	6.70	45	Pass	13.2	13.0
HITF05068	6.93	45	Pass	10.2	8.2
HITF04159	6.86	0	Fail	8.0	8.0
HITF04150	6.22	0	Fail	8.1	8.1
HITF04160	6.74	45	Fail	9.1	8.0
HITF04153	6.87	45	Fail	10.3	8.6

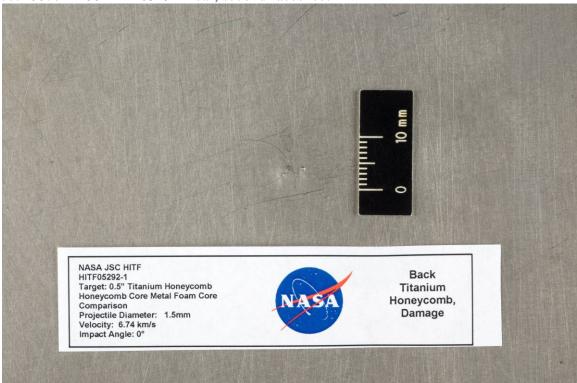
**Figure A-97**Jsc2007e14166 HITF05292 Rear, second facesheet

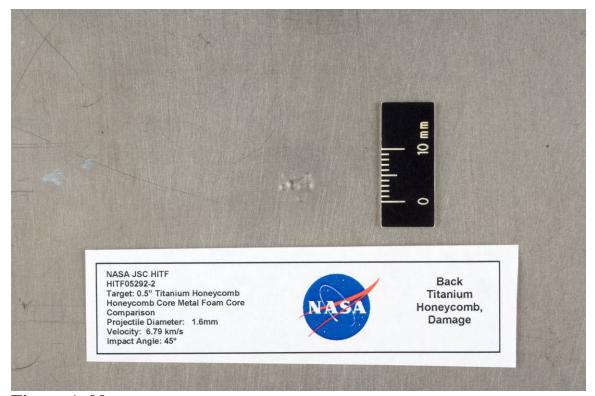
**Figure A-98**Jsc2007e14191 HITF05292-1 Rear, second facesheet

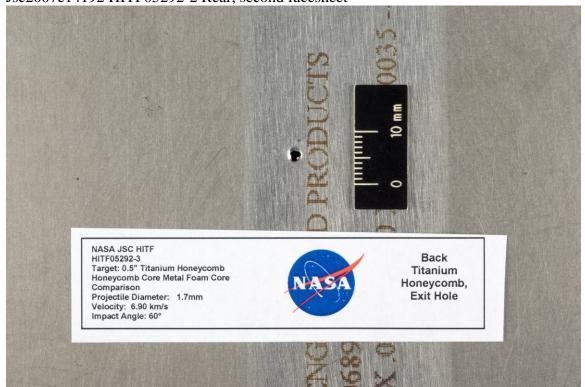
Figure A-99
Jsc2007e14192 HITF05292-2 Rear, second facesheet

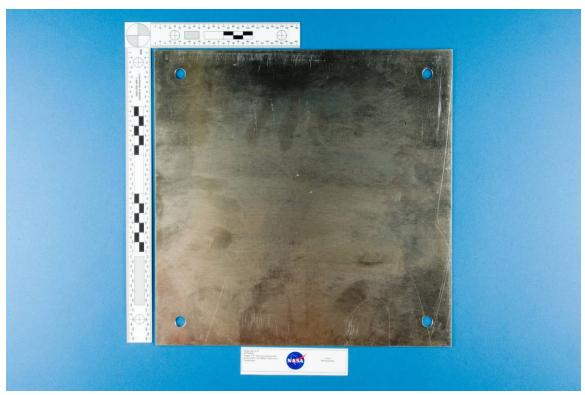
**Figure A-100**Jsc2007e14193 HITF05292-3 Rear, second facesheet

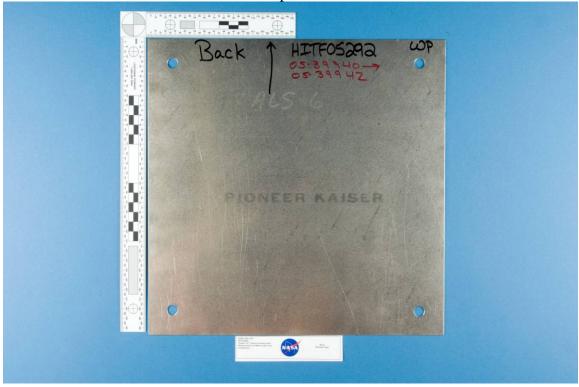
Figure A-101
Jsc2007e14163 HITF05292 Front, witness plate

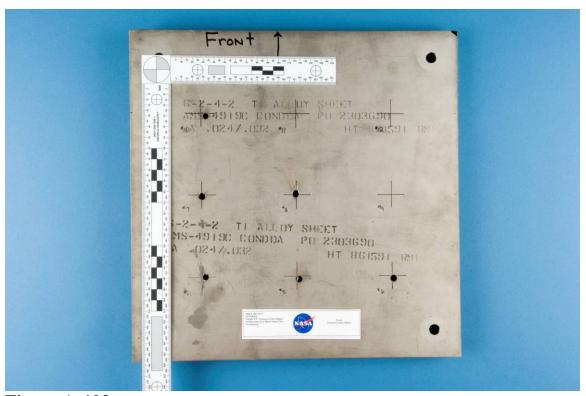
**Figure A-102**Jsc2007e14164 HITF05292 Rear, witness plate

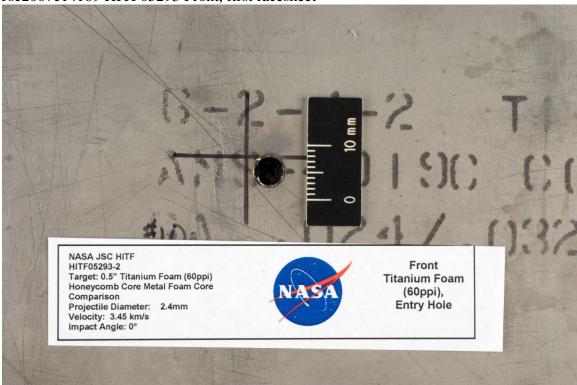
Figure A-103
Jsc2007e14169 HITF05293 Front, first facesheet

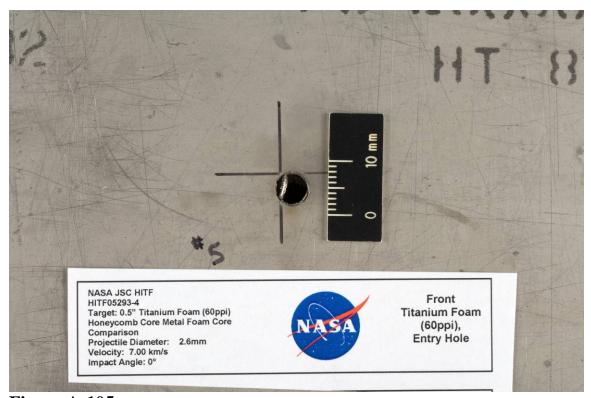
**Figure A-104**Jsc2007e14171 HITF05293-2 Front, first facesheet

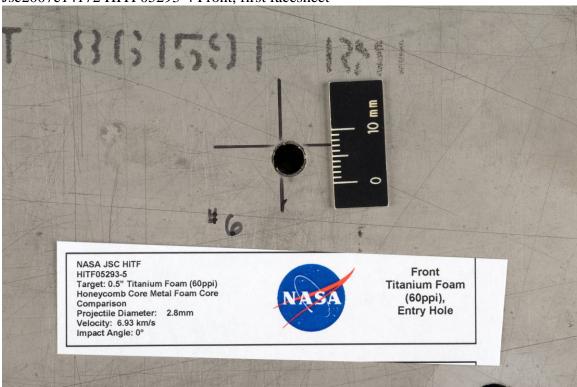
Figure A-105
Jsc2007e14172 HITF05293-4 Front, first facesheet

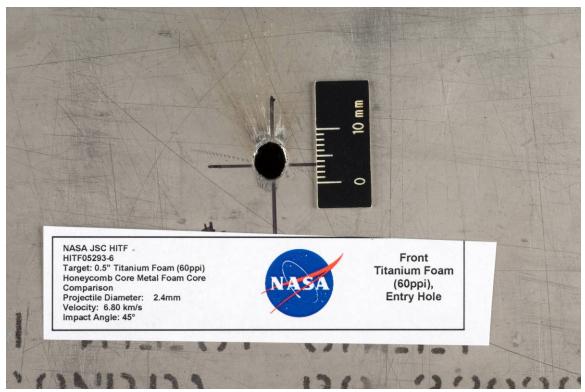
**Figure A-106**Jsc2007e14173 HITF05293-5 Front, first facesheet

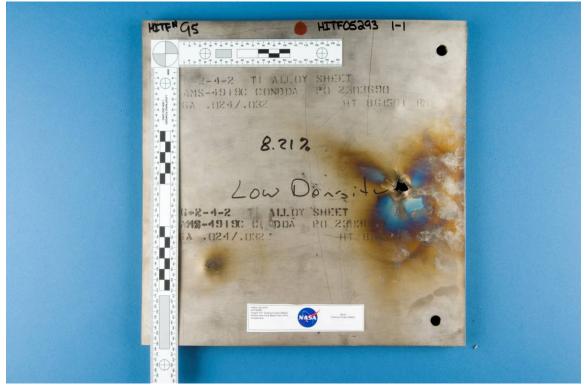
**Figure A-107**Jsc2007e14174 HITF05293-6 Front, first facesheet

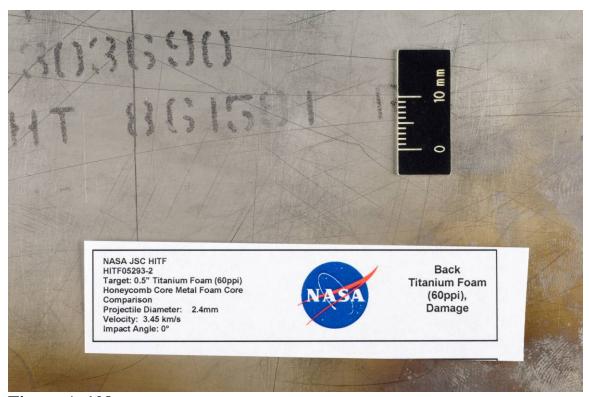
**Figure A-108**Jsc2007e14170 HITF05293 Rear, second facesheet

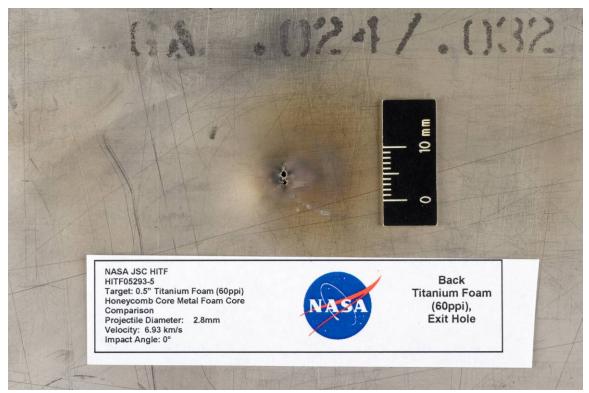
Figure A-110
Jsc2007e14176 HITF05293-4 Rear, second facesheet

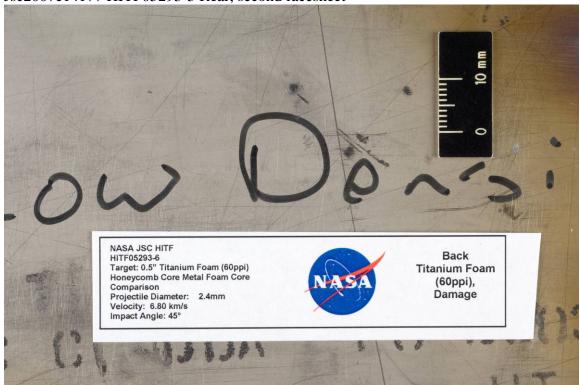
**Figure A-111**Jsc2007e14177 HITF05293-5 Rear, second facesheet

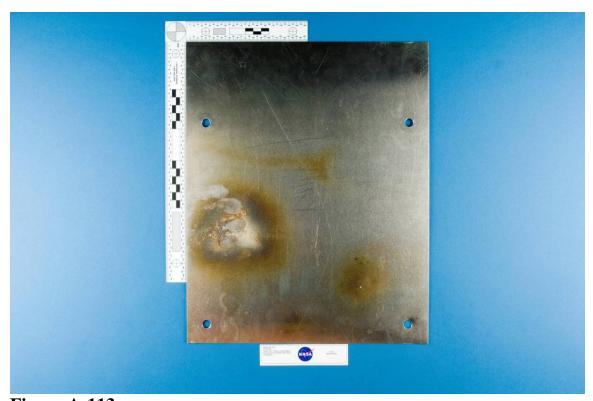
**Figure A-112** Jsc2007e14178 HITF05293-6 Rear, second facesheet

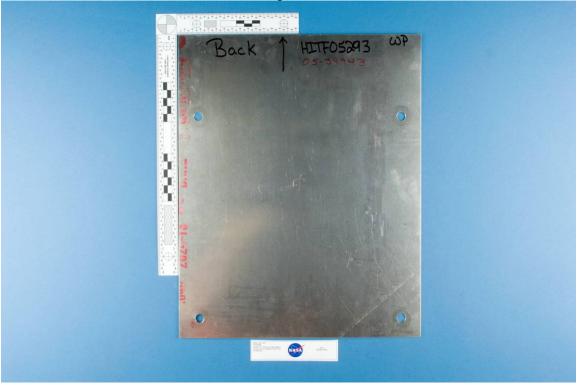
**Figure A-113**Jsc2007e14167 HITF05293 Front, witness plate

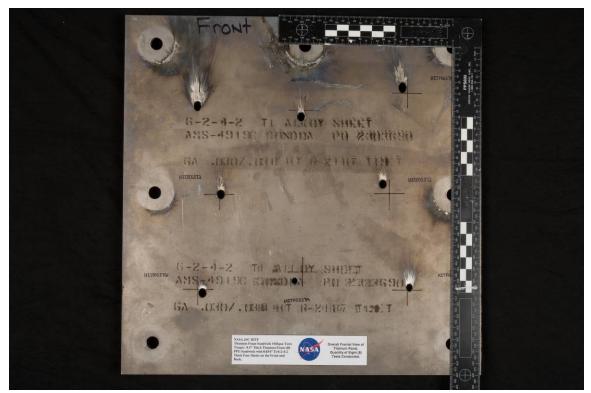
**Figure A-116**Jsc2006e13234 HITF05372 Front, first facesheet

NASA JSC HITP
Shot # HITPO5372
Target: Titenium Foan Sendanch Oblique
Test #1
Projectile Dia: 3.2mm
Velecity, 6.77 km/s
Impact Angle: 45°

Front View of Impact
Damage to Titenium Foan
Panel on Front Face
Sheet(0.034" Thick Ti-6-24-2 Face Sheets on Front
and Back of Panel)

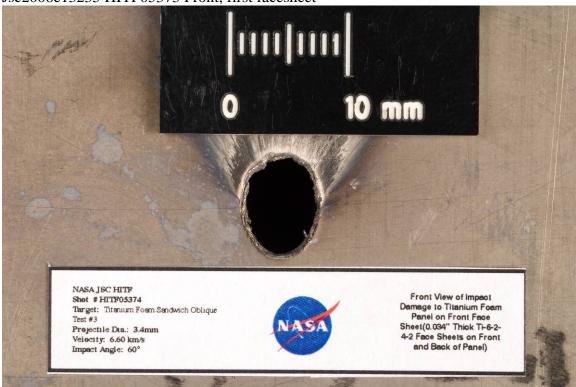
Figure A-117
Jsc2006e13235 HITF05373 Front, first facesheet

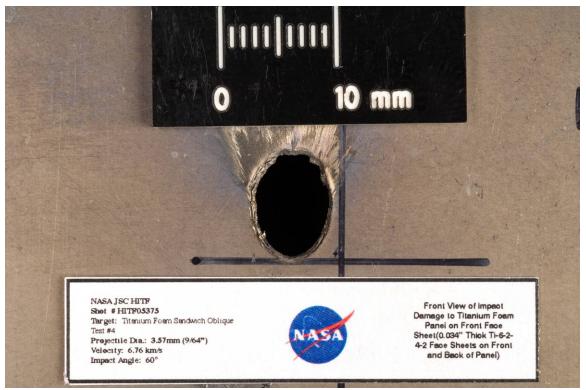
**Figure A-118**Jsc2006e13236 HITF05374 Front, first facesheet

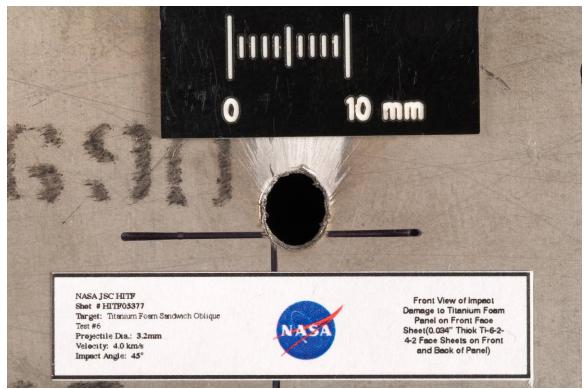
Figure A-120
Jsc2006e13238 HITF05376 Front, first facesheet

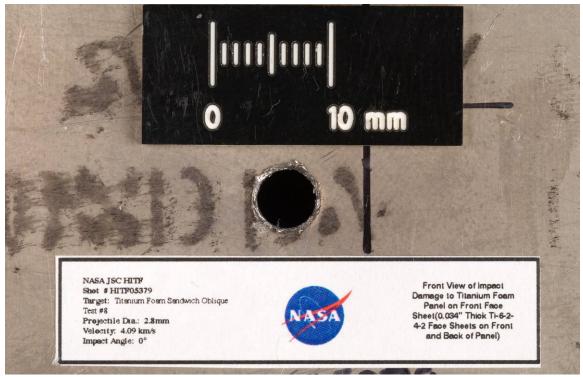
**Figure A-122** Jsc2006e13240 HITF05378 Front, first facesheet

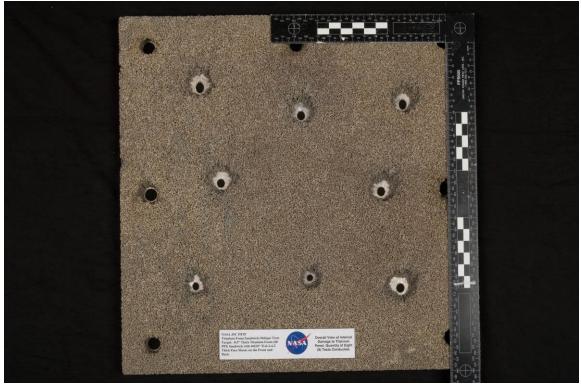
Figure A-123
Jsc2006e13241 HITF05379 Front, first facesheet
